# Lake Tarawera

## INFOSHEET 10, JANUARY 2018

*This information sheet has been prepared for Te Arawa whānau to summarise information about:*

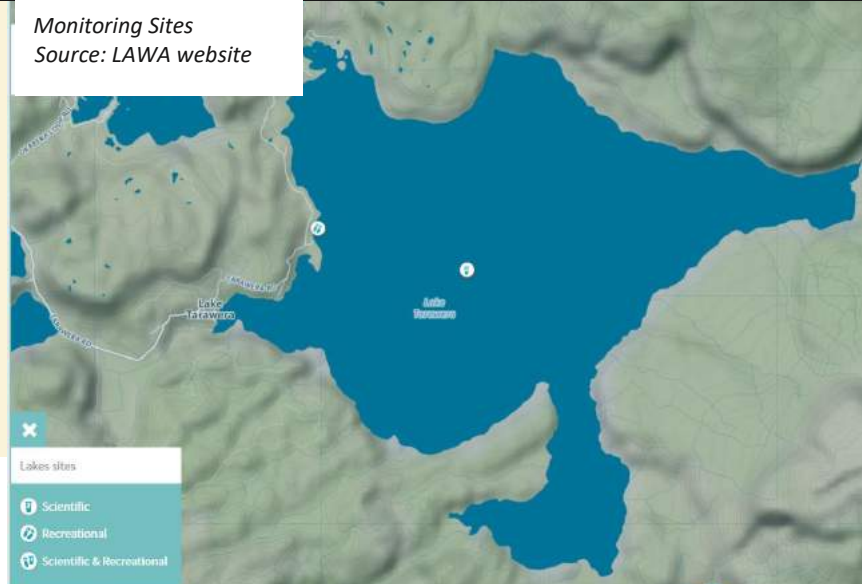
Monitoring Sites  
Source: LAWA website

- **Swimming water quality** – One site measured from October to June. Any health warnings are posted on the Regional Council and Toi Te Ora Public Health websites.

- **Scientific** – One site measured monthly for clarity, algae, phosphorous and nitrogen. Result articulated as the Trophic Level Index or TLI.

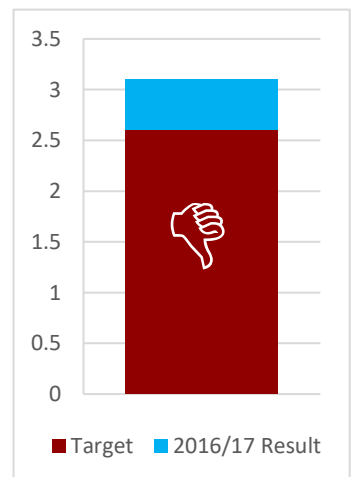
**TLI target not met.** For the 2016/17 year, the TLI was 3.1, which is over the target of 2.6.

The Trophic Level Index (TLI) is used to give an overall picture of the health of Lake Tarawera.
